# MiCODUS 2G Device Firmware Upgrade

## I. Upgrade Overview

### (I) Purpose of Upgrade

**MV710, MV720, MV730, MV740, MV760 and MV790.**

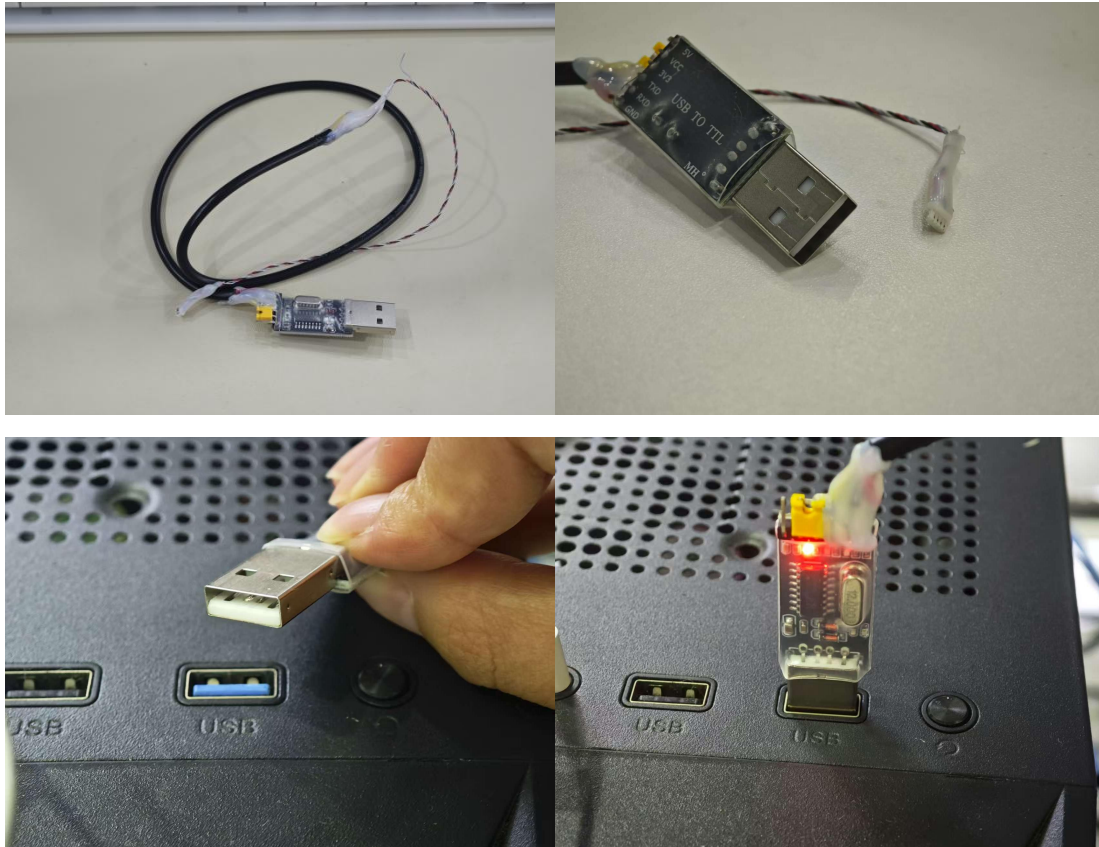
1. After installing the driver, connect the serial cable (configuration cable) to the USB port of the computer.
