MiCODUS 2G Device Firmware Upgrade

I. Upgrade Overview

(I) Purpose of Upgrade

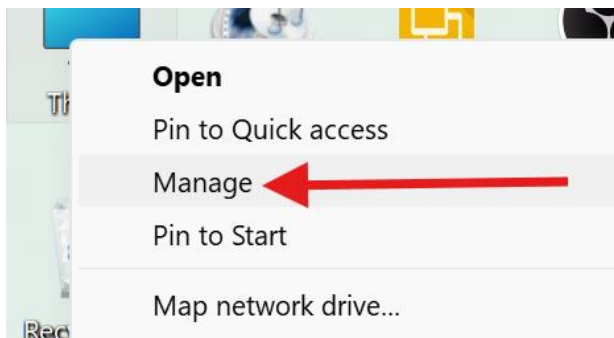
2. Right-click **“My Computer”** and select **“Manage”**. In the pop-up Computer Management window, navigate through **System Tools → Device Manager → Ports (COM & LPT)**. Locate **“USB-SERIAL CH340 (COMX)”** (where X is the specific port number, e.g., COM3) and note down the COM port number.

Note: If the port is not found, the driver may not have installed successfully or there may be an issue with the configuration cable. Recheck the driver installation and cable connection. If multiple COM ports are present, ensure you identify the one related to this connection.

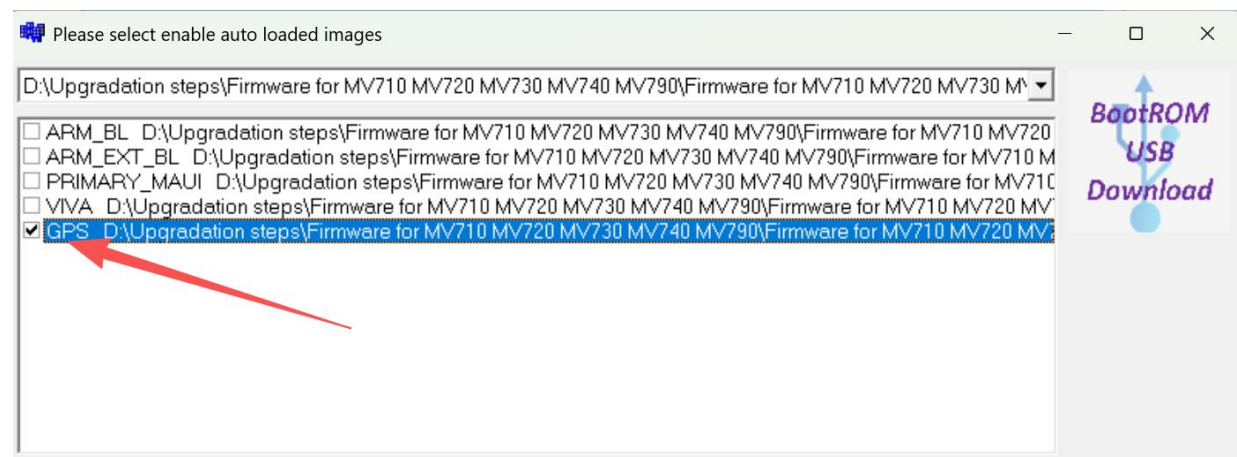
1. In the new pop-up window, locate the relevant options and check **only the “GPS” download item**. Ensure that all unrelated download items remain unchecked.
